## Luminary Micro Inc.

### ***RMA FAILURE ANALYSIS REPORT***

<b>Customer:</b>	Individual FRC Teams	<b>RMA #:</b>	Multiple
<b>Product #:</b>	MDL-BDC (Jaguar)	<b>Report Date:</b>	4/13/09
<b>Return Qty:</b>	136	<b>Author:</b>	Scott Emley

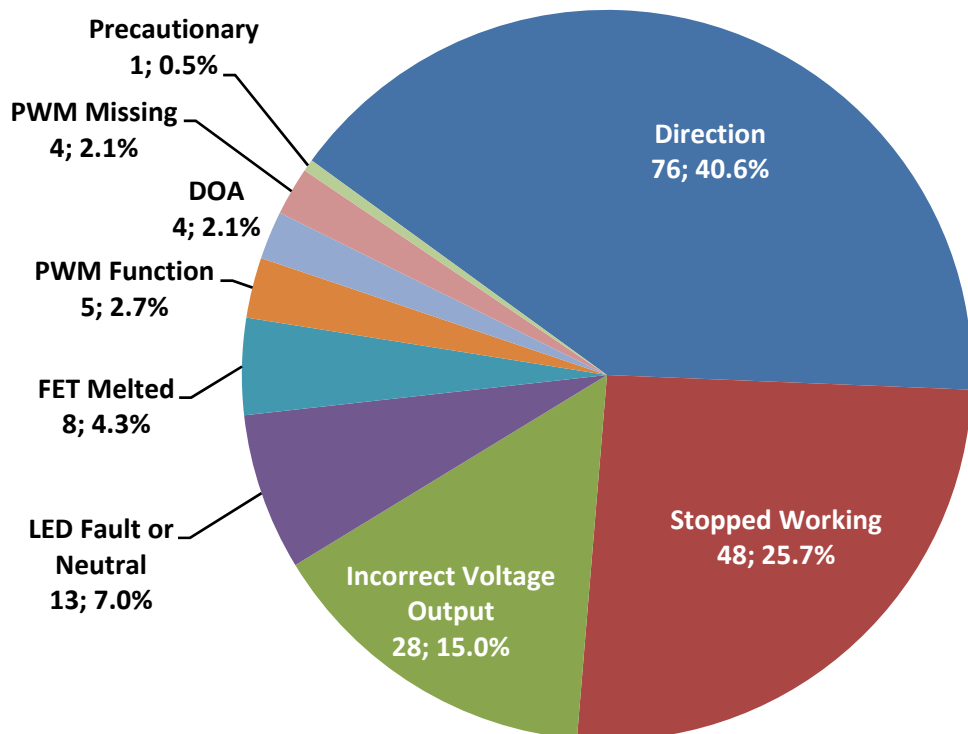
## 2.2 Summary of Failure Reports

Reported Failure	Count	Percent of Total
Direction	76	40.6%
Stopped Working	48	25.7%
Incorrect Voltage Output	28	15.0%
LED Fault or Neutral	13	7.0%
FET Melted	8	4.3%
PWM Function	5	2.7%
DOA	4	2.1%
PWM Missing	4	2.1%
Precautionary	1	0.5%

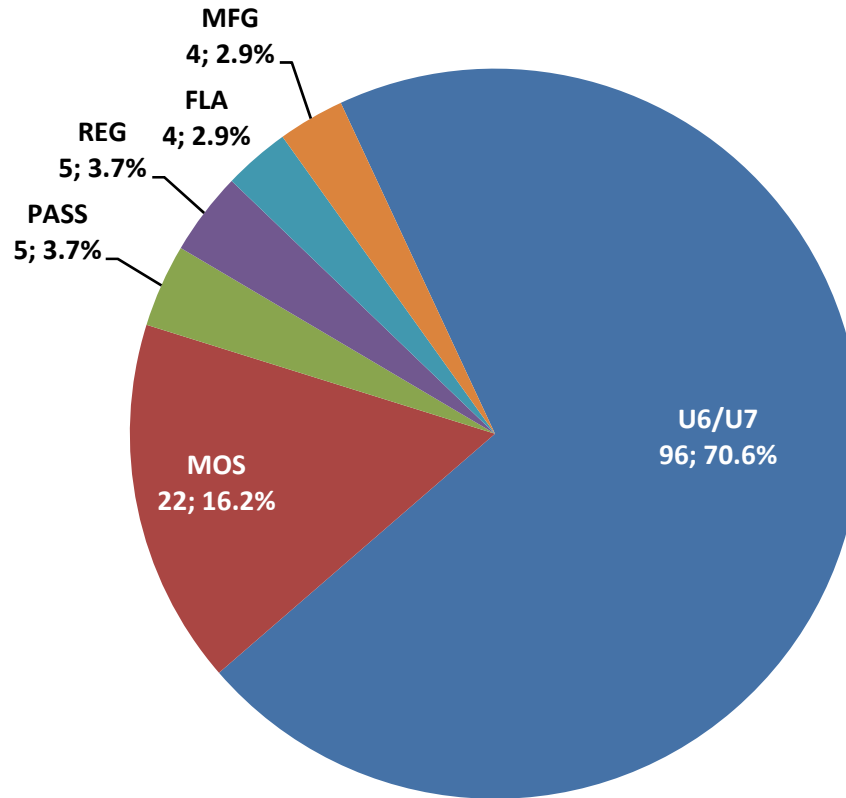
## 3.2 Summary of Failure Analyses

Failure Analysis Category	Count	Percent of Total
U6/U7	96	70.6%
MOS	22	16.2%
PASS	5	3.7%
REG	5	3.7%
FLA	4	2.9%
MFG	4	2.9%
