Issue: Talon SRX (with Ver 3.3 firmware) does not limit current in motor windings correctly.

Concern: The lack of proper current limiting is a potential safety concern for teams. The same issue that affects current limiting also affects the motor current returned by the Talon in response to a `getOutputCurrent()` function call. While not necessarily impacting safety, this may be confusing to teams trying to regulate motor torque based on measured current.

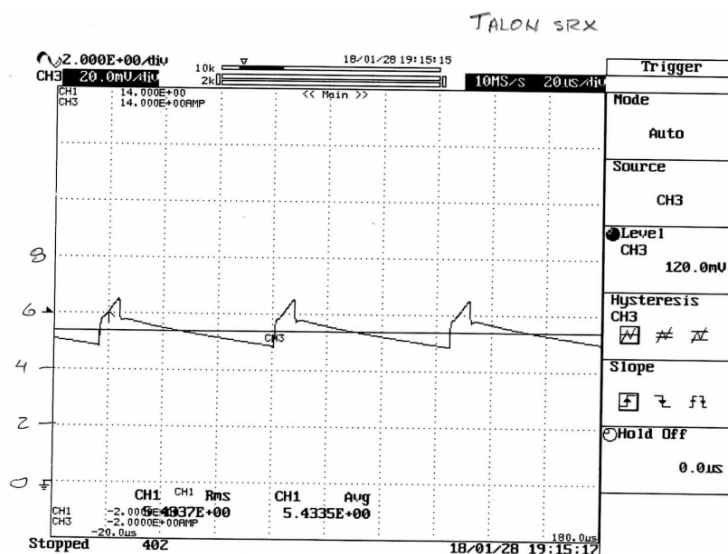
The Talon did not limit the current to the programmed value of 3 amps. Rather, it was the commanded voltage divided by the series resistance of the current shunt ($.020 \Omega$) plus motor winding (0.19Ω) that limited motor current.

Figure 8 Motor current when powered by Talon SRX.

The flat line is the average motor current (5.43 Amps at the moment the trace was captured). The trace from channel 3 clearly shows the

increase in current during the ON portion of the PWM cycle and the decrease during the OFF portion of the 64.1 μ Sec cycle. The mechanical time constant of the setup is significantly lower than the 400 Hz low pass filter used on channel 1. Therefore, the torque delivered at the output of the gearbox shaft is essentially constant.

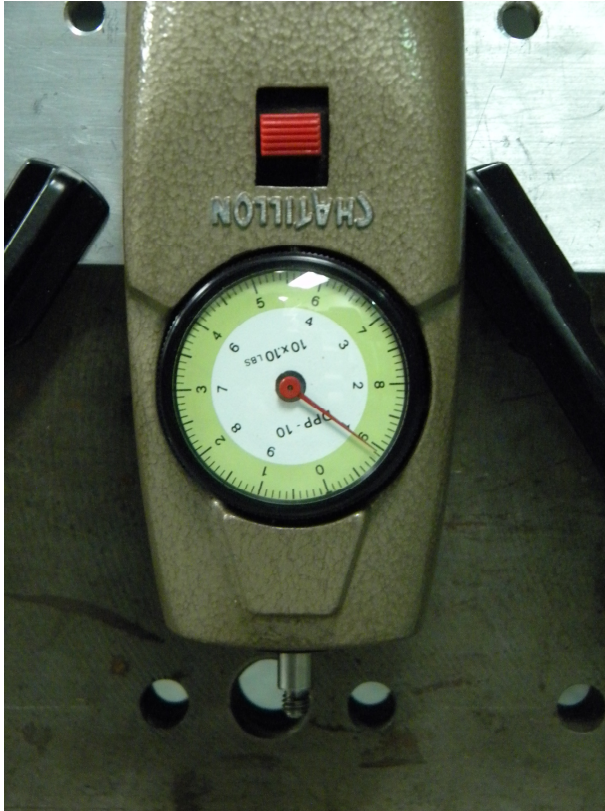
The indicated tension was similar to what was observed when driven by the DC source.

Figure 9 Tension when powered by Talon SRX at ~6 Amps.

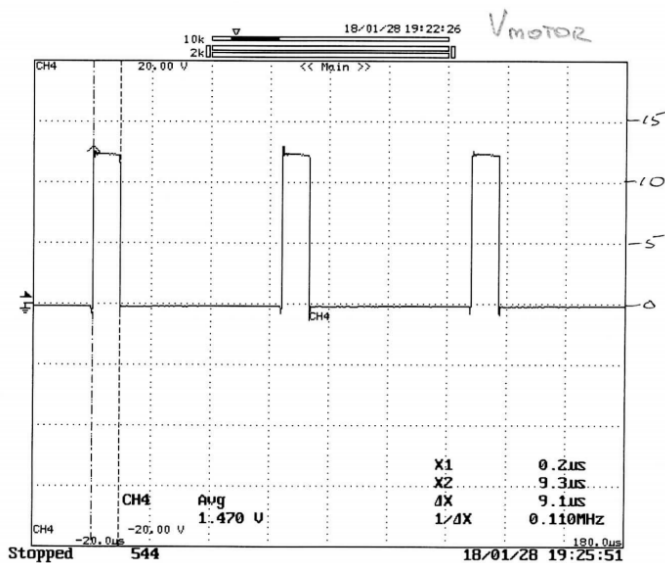
Figure 10 Motor voltage at motor terminals.

The duty cycle was $9.1/64.1$ or 14% which matched the commanded "percentOutput". The average motor voltage was 1.47 volts for an indicated power delivered of $1.47 * 6 = 8.8$ Watts.

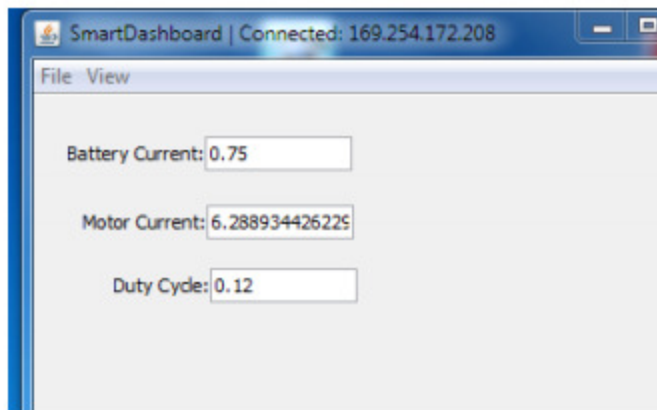
Figure 11 SmartDashboard readings from Talon SRX.

The value returned by the Talon is listed as "Battery Current". The ratio of motor voltage to bus voltage is displayed as "Duty Cycle". The value shown as "Motor Current" is the current reported by the Talon divided by the duty cycle. Note that the

Note that the reading returned by the Talon as "OutputCurrent" differs from the actual motor current by a factor of 8.4 (~1/.12) and the actual motor current is twice the value programmed as the limit on continuous current.

Clearly, there is a problem with the current measurement of the Talon and that measurement renders the current limit ineffective.

Meanwhile, until CTRE corrects the problem, Teams should be aware that the Talon SRX does NOT limit motor current (unless duty cycle = 100%, at which point motor voltage equals battery voltage and hence battery current = motor current). We found experimentally that, for our operating condition with a 30% voltage command, when the motor is stalled, a current limit setting of 1 resulted in ~10 Amps in our intake motors. This results in ~20 Watts dissipation in the motor which is tolerable over a 2.5 minute

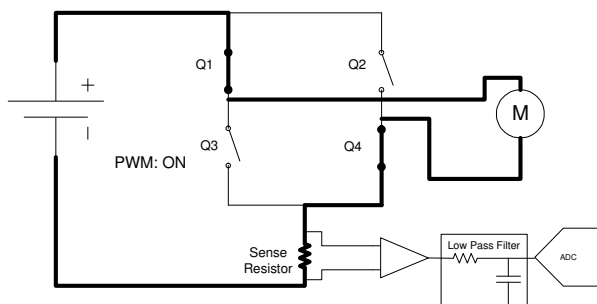
The Talon (apparently) measures current with a sense resistor on the low-side of the H-bridge. This is a well known means of measuring current in an H-bridge, though it does present some challenges. The current in the sense resistor is identical to the current in the

motor windings only during the ON portion of the PWM cycle (see Figure 12).

Figure 12 Motor current passes through low side sense resistor during ON portion of PWM cycle.

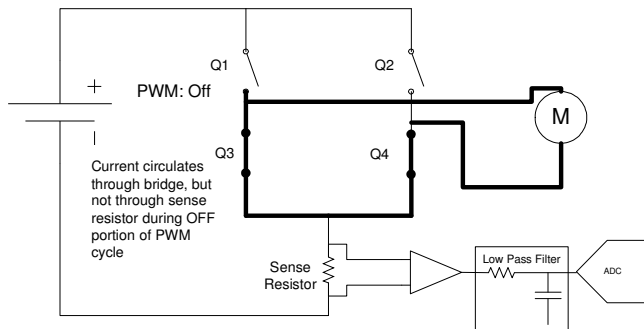
During the OFF portion of the cycle, the motor current circulates through the FET switches without passing across the sense resistor.

Figure 13 Motor current circulates within H-bridge during OFF portion of cycle, bypassing sense resistor.

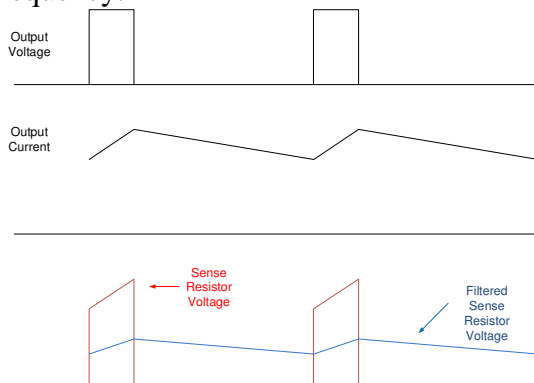
Figure 14 Output voltage, motor current and sense resistor voltage during PWM cycle.

The ADC requirements are much relaxed and the short duration voltage transients have much less impact on the average voltage measurement. However, the resulting voltage is therefore indicative of the current drawn from the battery, not the current in the motor windings. The winding

current can be estimated however, by realizing that the motor current must be related to the battery current by the ratio of battery voltage to motor voltage (subject to minor losses in the Talon) due to conservation of energy. Also, the voltage ratio is simply the inverse of the PWM duty cycle.

The Talon is reporting actual battery current rather than motor current due to the lack of correcting the current sense voltage by the PWM duty cycle. Fortunately, it should be a simple matter for CTRE to correct this error with a software revision.
