Issue: Talon SRX (with Ver 3.3 firmware) does not limit current in motor windings correctly.

Concern: The lack of proper current limiting is a potential safety concern for teams. The same issue that affects current limiting also affects the motor current returned by the Talon in response to a `getOutputCurrent()` function call. While not necessarily impacting safety, this may be confusing to teams trying to regulate motor torque based on measured current.

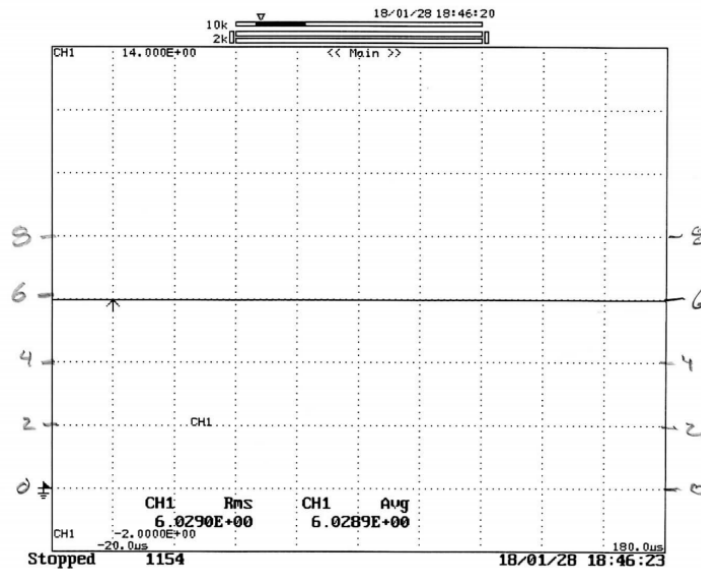
With a DC source driving the motor, the current measured with the oscilloscope confirmed the measurement across the shunt resistor reported by the DVM.

Figure 5 Motor current with DC source: 6.03 Amps.

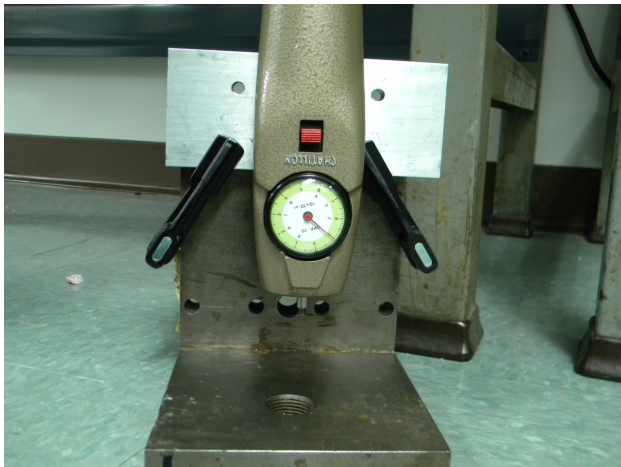
The force gauge indicated a tension in the floss of ~1 lb (~4.45 N). However, the friction in the gearbox made the force measurement less certain. Turning the power source on and off indicated a clear increase/decrease of tension in the floss.

Figure 6 Force gauge indicating 1 lb tension with DC source.

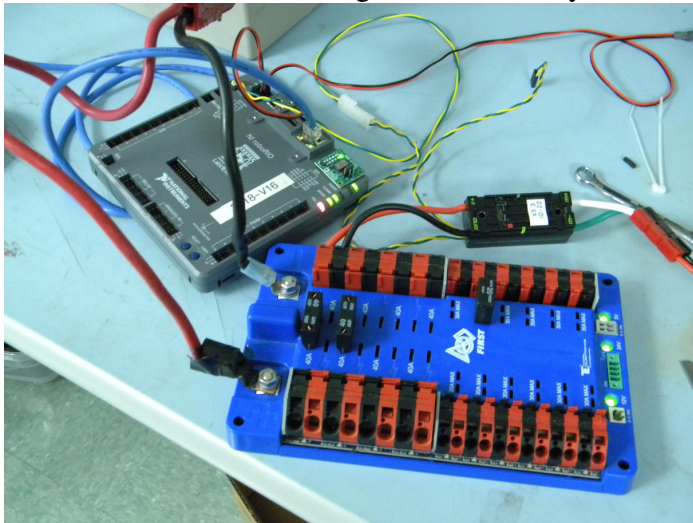
Figure 7 roboRIO and power control panel used to power Talon SRX.

The Talon did not limit the current to the programmed value of 3 amps. Rather, it was the commanded voltage divided by the series resistance of the current shunt ($.020 \Omega$) plus motor winding (0.19Ω) that limited motor current.

Meanwhile, until CTRE corrects the problem, Teams should be aware that the Talon SRX does NOT limit motor current (unless duty cycle = 100%, at which point motor voltage equals battery voltage and hence battery current = motor current). We found experimentally that, for our operating condition with a 30% voltage command, when the motor is stalled, a current limit setting of 1 resulted in ~10 Amps in our intake motors. This results in ~20 Watts dissipation in the motor which is tolerable over a 2.5 minute
